Sky Island Alliance appreciates the opportunity to provide feedback on the **Border Barrier Remediation Plan for Pima County, Santa Cruz County, and Cochise County (January 2022)**. The 119 miles of border within the scope of the plan runs through a world-renowned biodiversity hotspot and is home to many threatened and endangered species including jaguar and native fish such as the desert sucker and longfin dace. Border wall and associated infrastructure construction created massive environmental damage which requires urgent and extensive mitigation and restoration. The remediation plan as proposed focuses on stabilizing border infrastructure, is not significantly improving environmental conditions, and will lead to more environmental damage and degradation if more wall is built to close gaps.

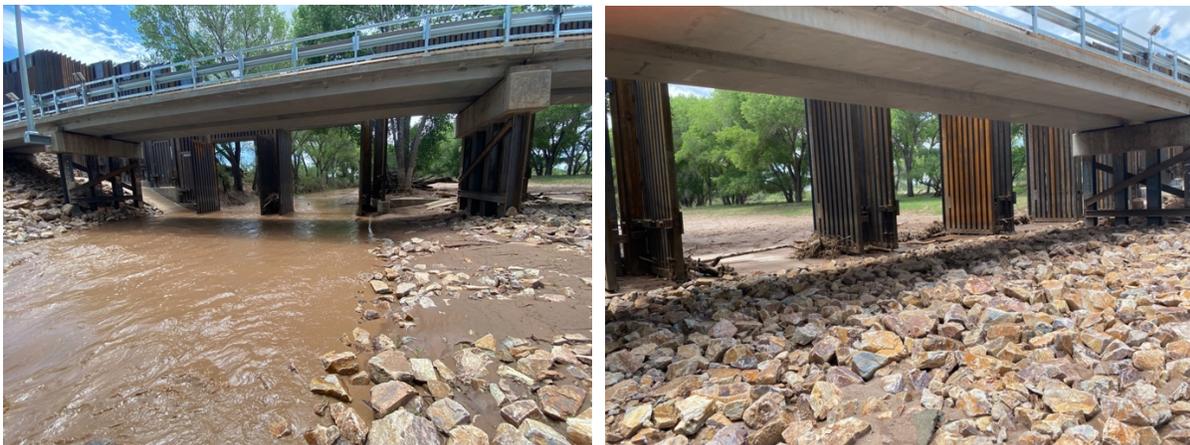
**Figure 1.** Gates across the San Pedro River in the San Pedro River National Conservation Area should remain open continuously to allow wildlife movement and migration regardless of whether water is flowing as this is a primary migratory corridor within the region. Photos taken in August 2021 by Robert Luce showing low river flow (left) and no river flow (right).

**Keep gates across rivers and water courses open year-round** on the San Pedro River (Figure 1), Silver Creek, Black Draw, Hay Hollow, and other wash crossings on public lands to reopen vital wildlife corridors during dry seasons when wildlife must be able to move in search of water on the landscape.

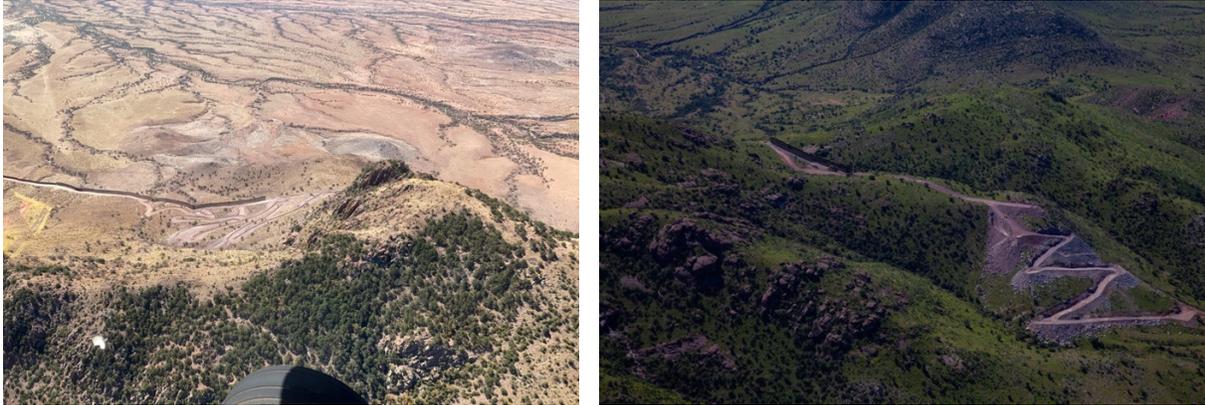
**Figure 2.** The recently built border access roads segments cut switchbacks up the steep terrain of the eastern Huachuca Mountains on Coronado National Monument past the end of the border wall (left) and on the western side of the Huachuca Mountains on Coronado National Forest (right). Both segments of road are highly unstable, already eroding, and should be restored to prevent further environmental damage. Photos taken in summer 2021 by Greg Bedinger/LightHawk.

**Decommission patrol road extensions.** New border roads into previously inaccessible high-elevation areas pose security and severe erosion risks to Sky Island habitats. The patrol road extensions in Coronado National Forest, Coronado National Monument, and Guadalupe Canyon should be decommissioned and the habitat restored under the direction of public land managers. By closing and decommissioning unnecessary patrol road segments, this will immediately reduce the disturbance of vehicles within wildlife corridors. In addition, the road prism should be reduced to a minimum width by revegetating with native plants in consultation with federal public land managers. Priority road segments for decommissioning are:

- Decommission patrol road extension on Coronado National Forest west of the Patagonia Mountains. Terminate border road at end of wall/FS Road 4903:
  - 31.33369, -110.79231
- Terminate the border road on Coronado National Forest at Yaqui Spring FS Road west of Huachuca Mountain switchbacks and decommission patrol road extension (Figure 2):
  - 31.33381, -110.2922
- Terminate the border road on Coronado National Memorial east of the switchbacks and decommission the patrol road extension (Figure 2):

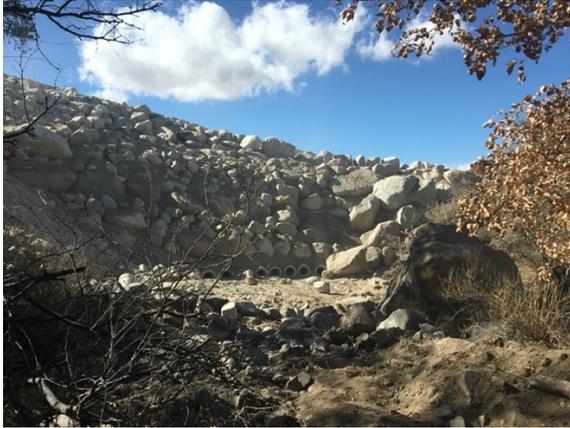
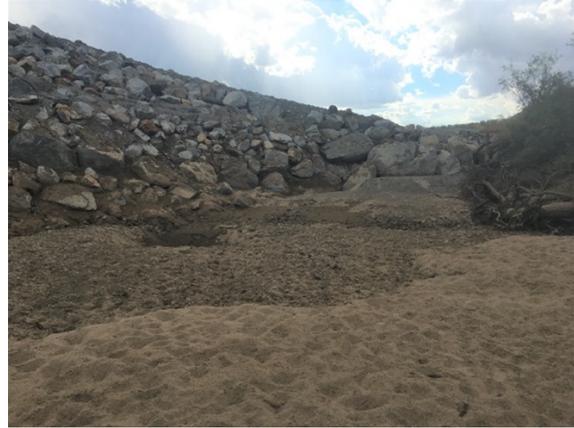
For example, on the border in the western Patagonia Mountains, a new access road was hastily built across a drainage with only 8, 16" culverts at the base of roadbed in January 2021 (Figure 3). The culverts were blocked and buried by sediment during the first monsoon season since construction when the road functionally became a dam (Figure 3). In this case, the access road in this segment should be decommissioned and the roadbed sediment removed to recontour the drainage. There is no reason to reinforce this unnecessary road fragment by protecting the 8-pipe culvert system that is currently buried and ineffective. This road segment is in the Patagonia Unit of jaguar Designated Critical Habitat and warrants full habitat restoration.

**Figure 3.** Eight 16”-diameter culverts line the base of a deep border access road that was built across a drainage with the patrol road extension in the western Patagonia Mountains on Coronado National Forest (left, Spring 2021 prior to monsoon rains). The same patrol road extension became a dam after the insufficient 8-pipe culvert system at the base was blocked and buried with sediment during heavy monsoon rains in August 2021 (right). This drainage in Coronado National Forest should be restored by removing the border access road above to allow natural drainage south across the border again.

**Improve water crossings** (applies to culverts and low water crossings) by ensuring capacity to tolerate 100-year storm events. Recontouring the drainage with minimal obstructions to permit natural water flow is preferred, but where that is not possible flood gates and culverts at water crossings must be large and open to prevent blockages behind the border infrastructure and reduce the risk of flooding that leads to erosion, further habitat loss, and risk to human safety.
